OFFICIAL PROJECT NO. 245-5707 UNDER DIRECTION OF UNITED STATES DEPARTMENT OF THE INTERIOR NATIONAL PARK SERVICE. BRANCH OF PLANS AND DESIGN

MISSION SAN BUENAVENTURA VENTURA COUNTY CALIFORNIA

SURVEY NO. CAL. 22 HISTORIC AMERICAN BUILDINGS SURVEY SHEET 2 OF 10 SHEETS

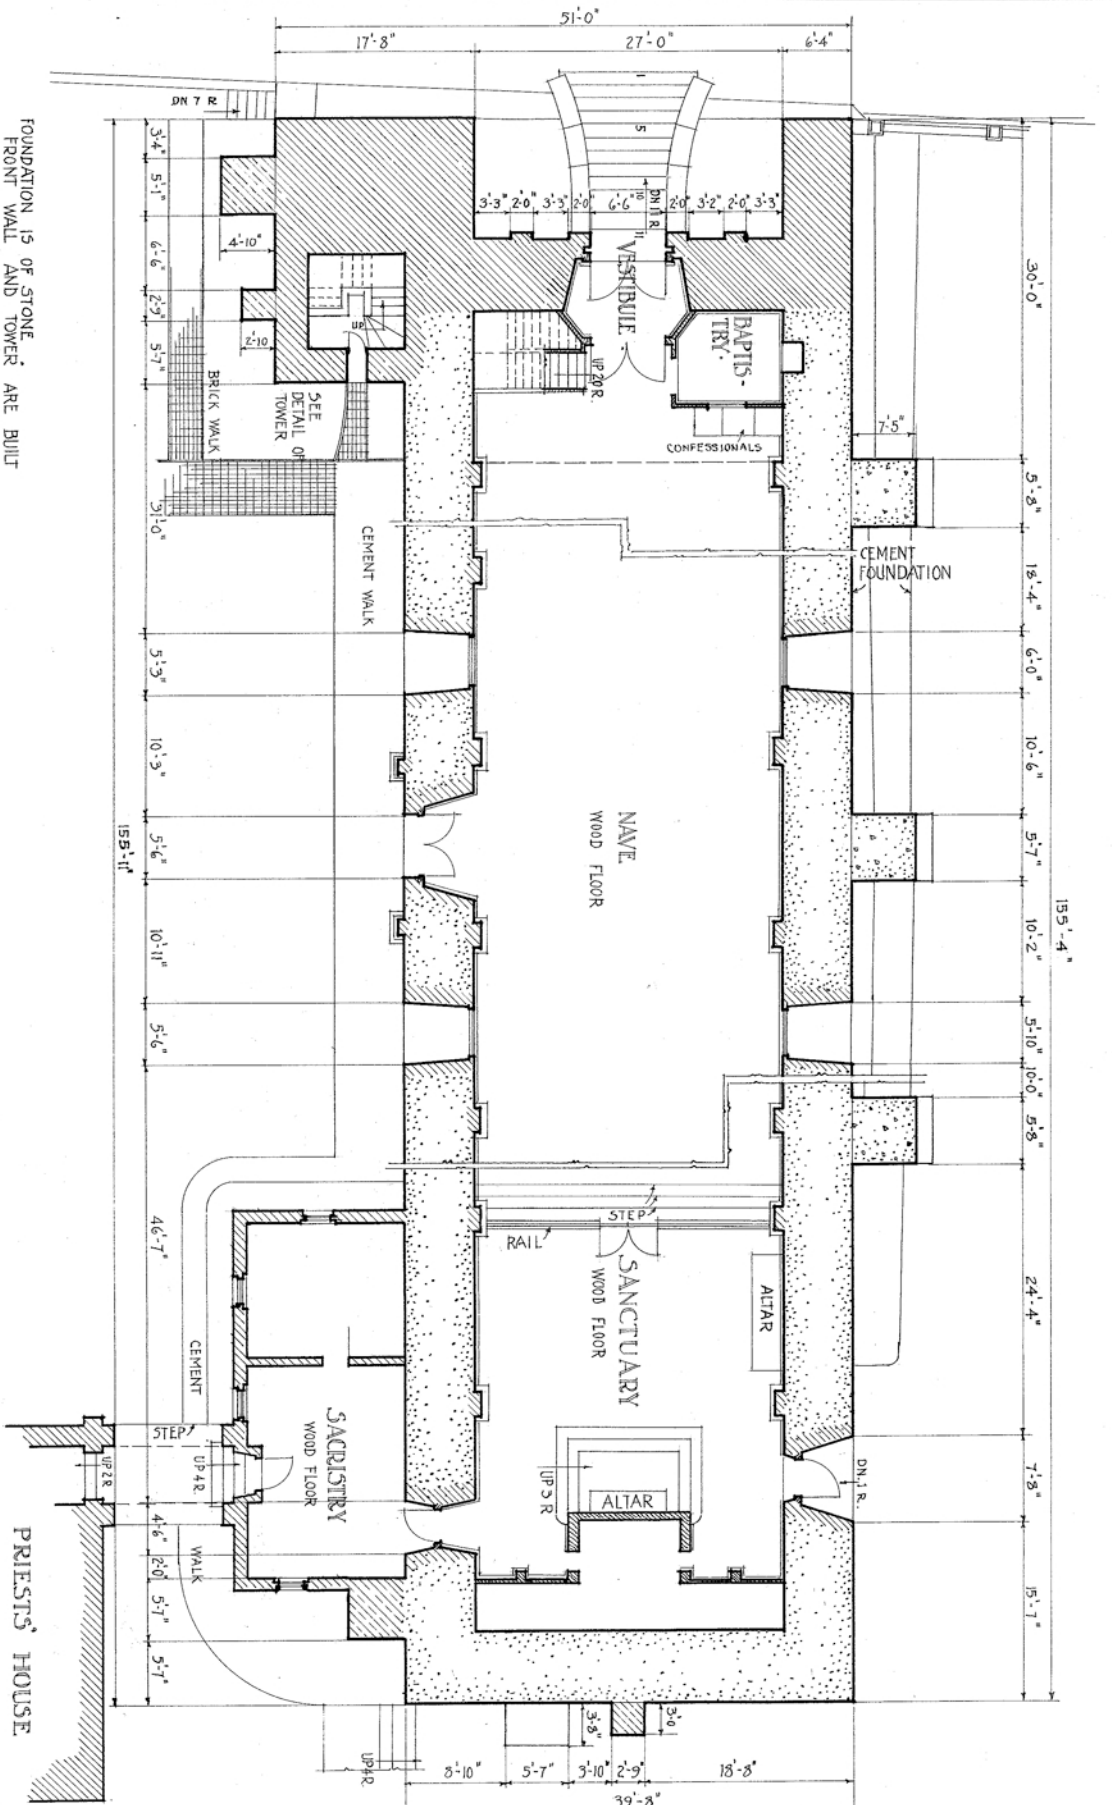
FLOOR PLAN SCALE 1/8" = 1'-0"

FOUNDATION IS OF STONE. FRONT WALL AND TOWER ARE BUILT OF BRICK. SIDE AND REAR WALLS OF ADOBE PATCHED OR REPAIRED IN PART WITH BRICK AND STONE. BUTTRESSES ON WEST SIDE ARE OF CONCRETE, THAI ON FRONT OF BRICK, THOSE ON EAST SIDE AND ON REAR ARE OF STONE.

WALLS PLASTERED BOTH SIDES, PAINTED ON EXTERIOR A REDDISH YELLOW. INTERIOR WALLS ARE PAINTED AND STENCILLED. CORNICES, MOULDINGS ON TOWER AND MIDDLE COURSES OF PLASTER ETC. ON SOUTH FRONT ARE OF UNPLASTERED BRICK. BRICK COURSES ON TOWER AND PLASTER AND ORNAMENT AT EAST ENTRANCE PAINTED RED. ORIGINAL ROOF FRAMING HAS BEEN ENTIRELY REPLACED. ROOF OVERHANG IS WOOD. PAINTED BLUE GREEN. ROOF TILE IS MODERN. STEEL ANGLES AND RODS WERE ADDED TO UPPER PART OF TOWER IN 1906 TO SAVE DESTRUCTION. THEY ARE NOT SHOWN.

ORIGINAL WINDOWS WERE LENGTHENED AND REPLACED WITH STAINED GLASS 9.5" IN ABOUT 1890. PRESENT SACRISTY, PRIESTS HOUSE, SCHOOL AND SISTERS HOUSE WERE ERRECTED IN 1922. MUSEUM BUILT IN 1922.
